(NASA-CR-193902) FINAL POSTFLIGHT
HARDWARE EVALUATION REPORT RSRM-28
(STS-53) Final Report (Thiokol
Corp.) 285 p

TWR-64216

Final Postflight Hardware Evaluation Report RSRM-28 (STS-53)

November 1993

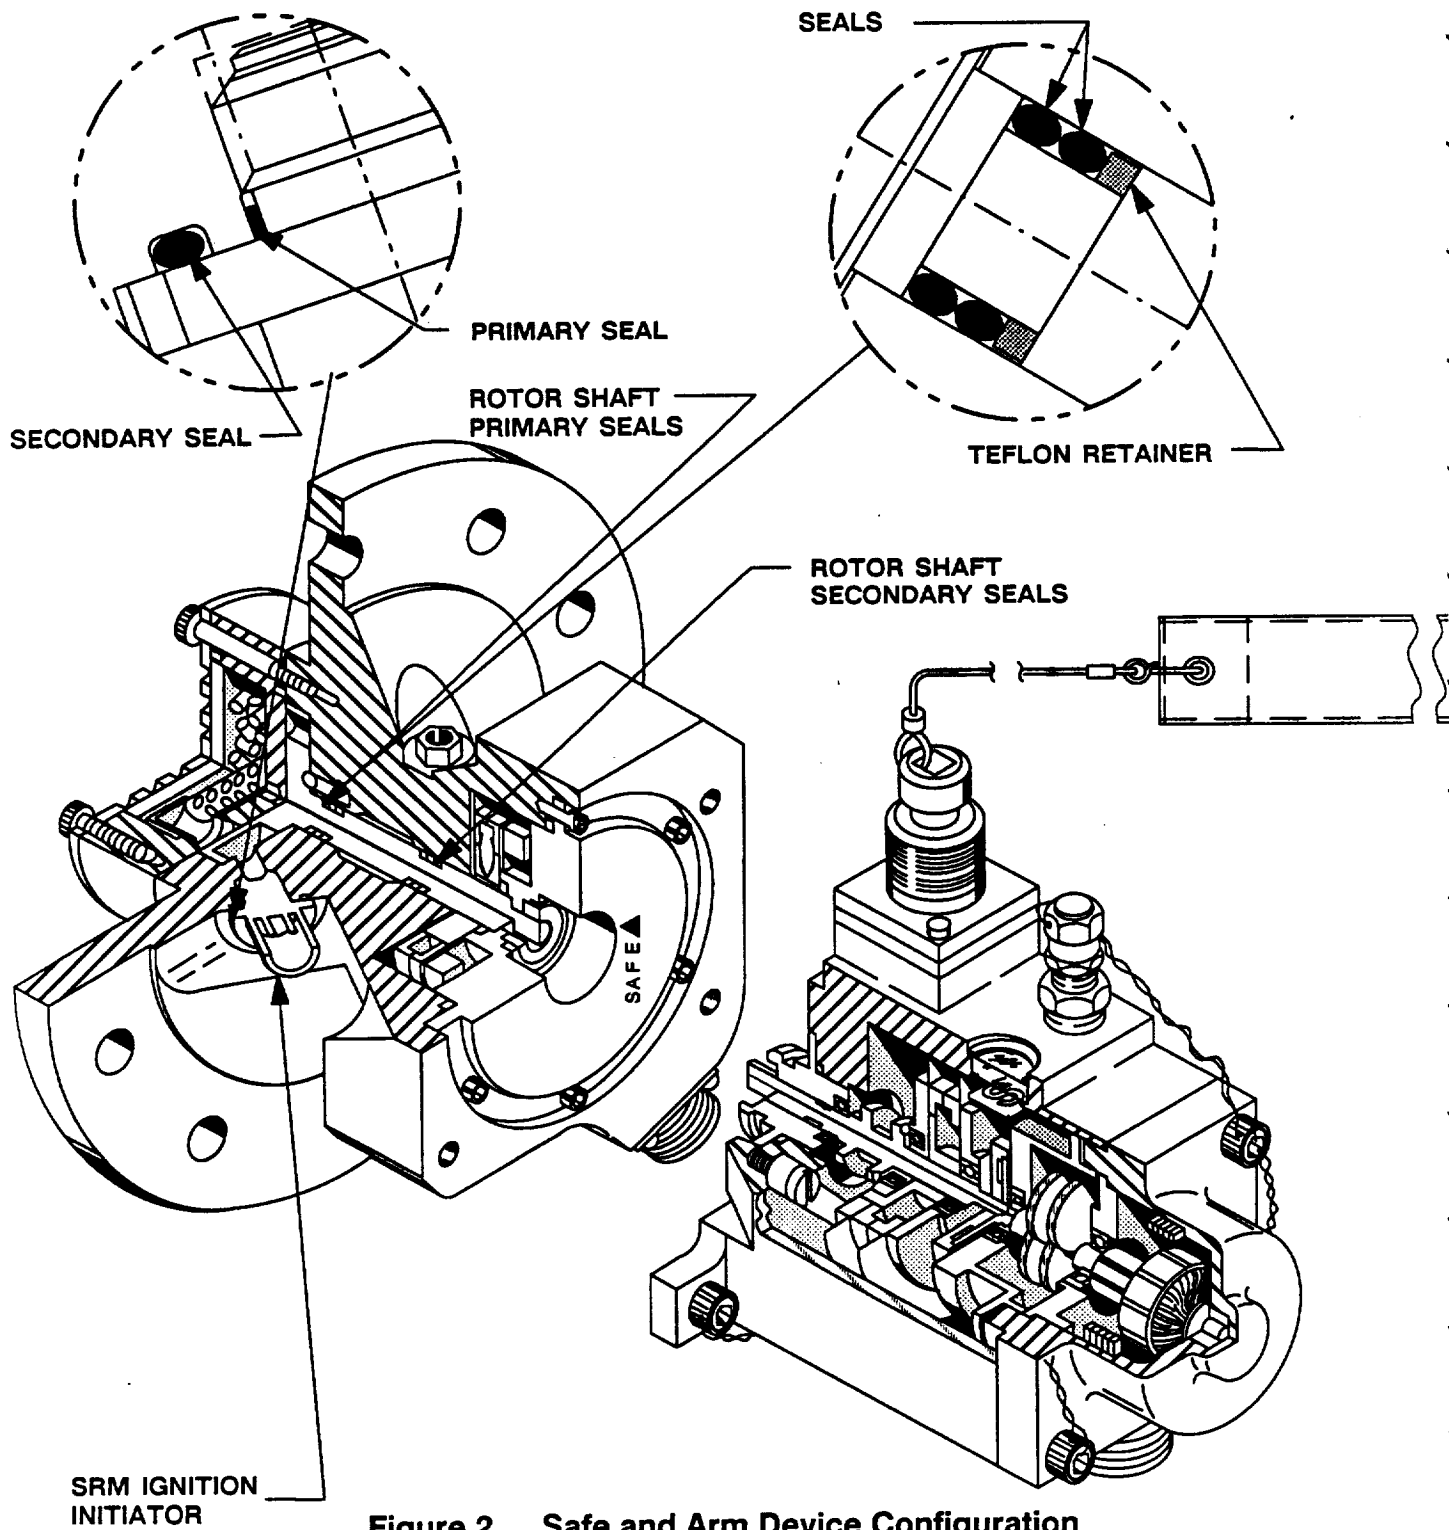
Figure 2. Safe and Arm Device Configuration

One anomalous condition was observed. Minor thread damage (two small dings) was observed on the first thread of the safing pin retainer (arming monitor). Small metal shavings were present in the safing pin retainer cap. (See Preliminary PFAR 53C-08.)

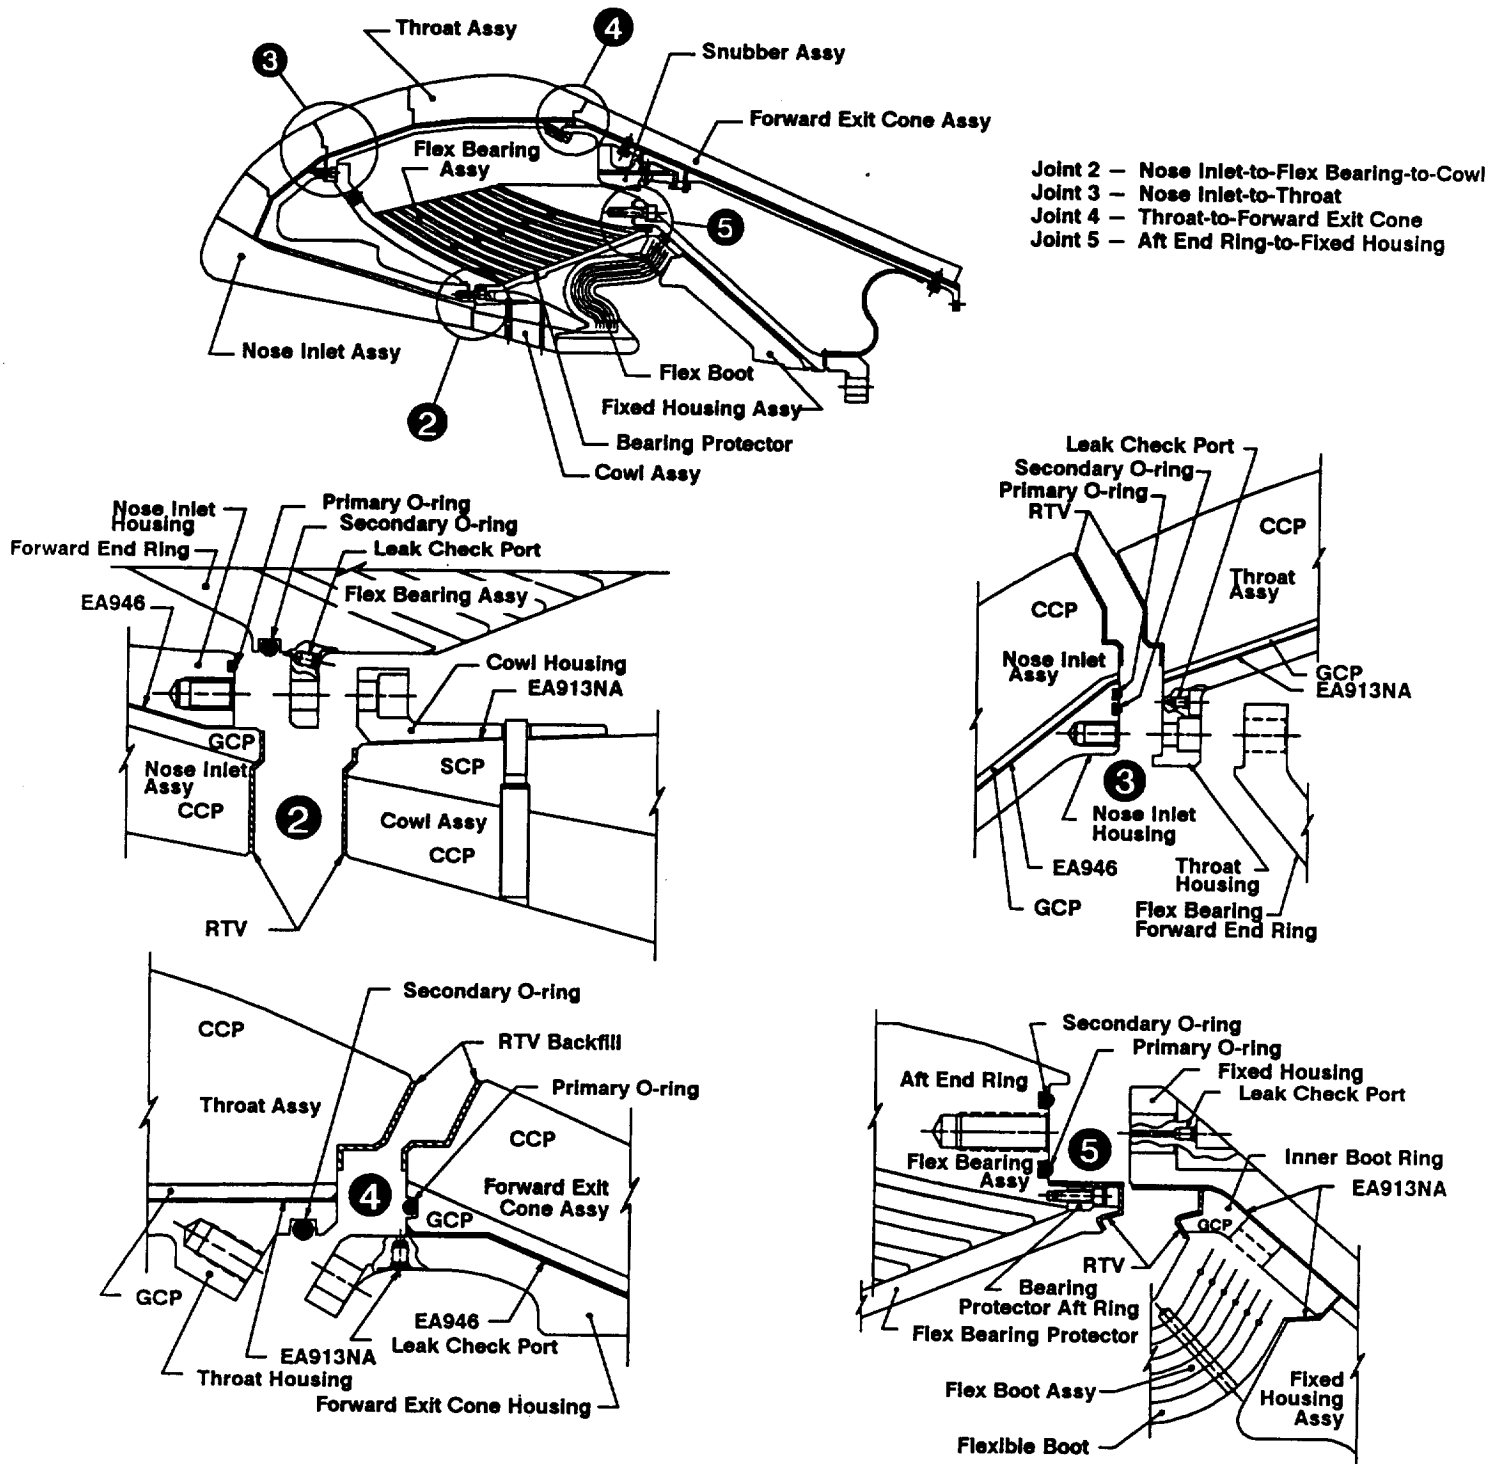
Figure 3. Internal Nozzle Joint Configuration

Grease coverage on the joint metal surfaces was nominal. No excessive grease was found in the bolt holes. Medium-to-heavy corrosion was observed on the forward end chamfer of the cowl housing from 205-to-305 degrees. Intermittent medium-to-heavy corrosion was observed on the ID of cowl housing flange full circumference. Light corrosion was observed on the forward end ring flange forward face full circumference. No metal damage was observed.

No separations were observed on the cowl assembly or aft end of the nose cap.
